**NBSIR 82-2465**

# **Investigation of the Kansas City Hyatt Regency Walkways Collapse**

U.S. DEPARTMENT OF COMMERCE  
National Bureau of Standards  
Washington, DC 20234

February 1982

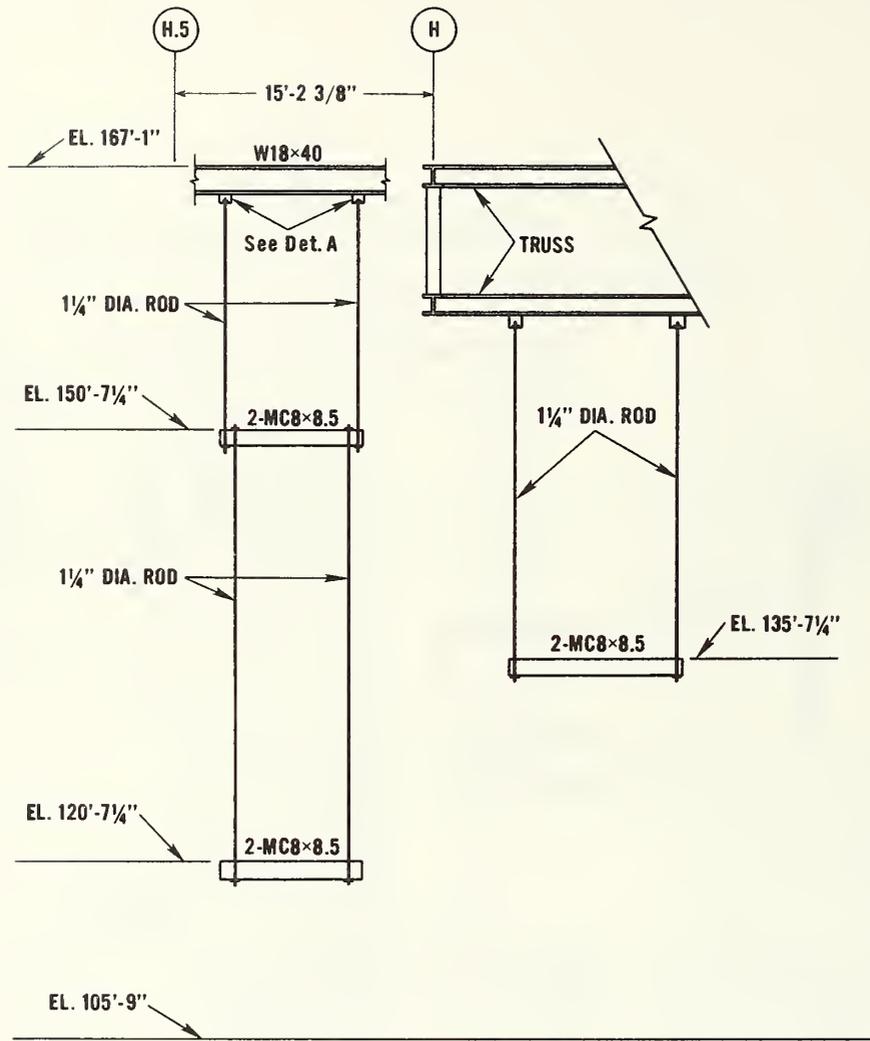
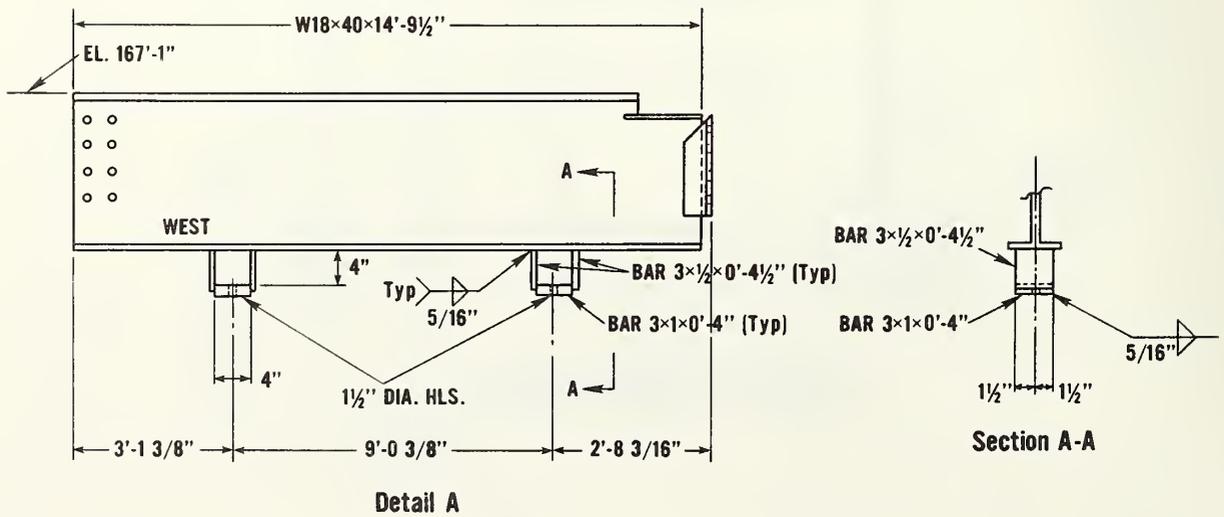
2. Of the three walkways, the second floor walkway was most easily accessible from the atrium main floor. The third floor walkway served the hotel ballroom and, because of its greater width, was evidently intended to carry larger volumes of traffic than the second or fourth floor walkways. The fourth floor walkway was the least accessible and is likely to have carried less traffic than the other two walkways.
3. The walkway spans were apparently designed to act as composite beams and were constructed without shores (i.e., it is assumed that the concrete deck does not participate in resisting forces and moments due to self-weight of the concrete and structural steel).
4. In preparing the shop drawings, two hanger rods with a 4 in (102 mm) offset at the fourth floor walkway were substituted for the single continuous hanger rod arrangement detailed on the contract drawings.

Figure 3.11 Elevation of typical box beam-hanger rod assembly.

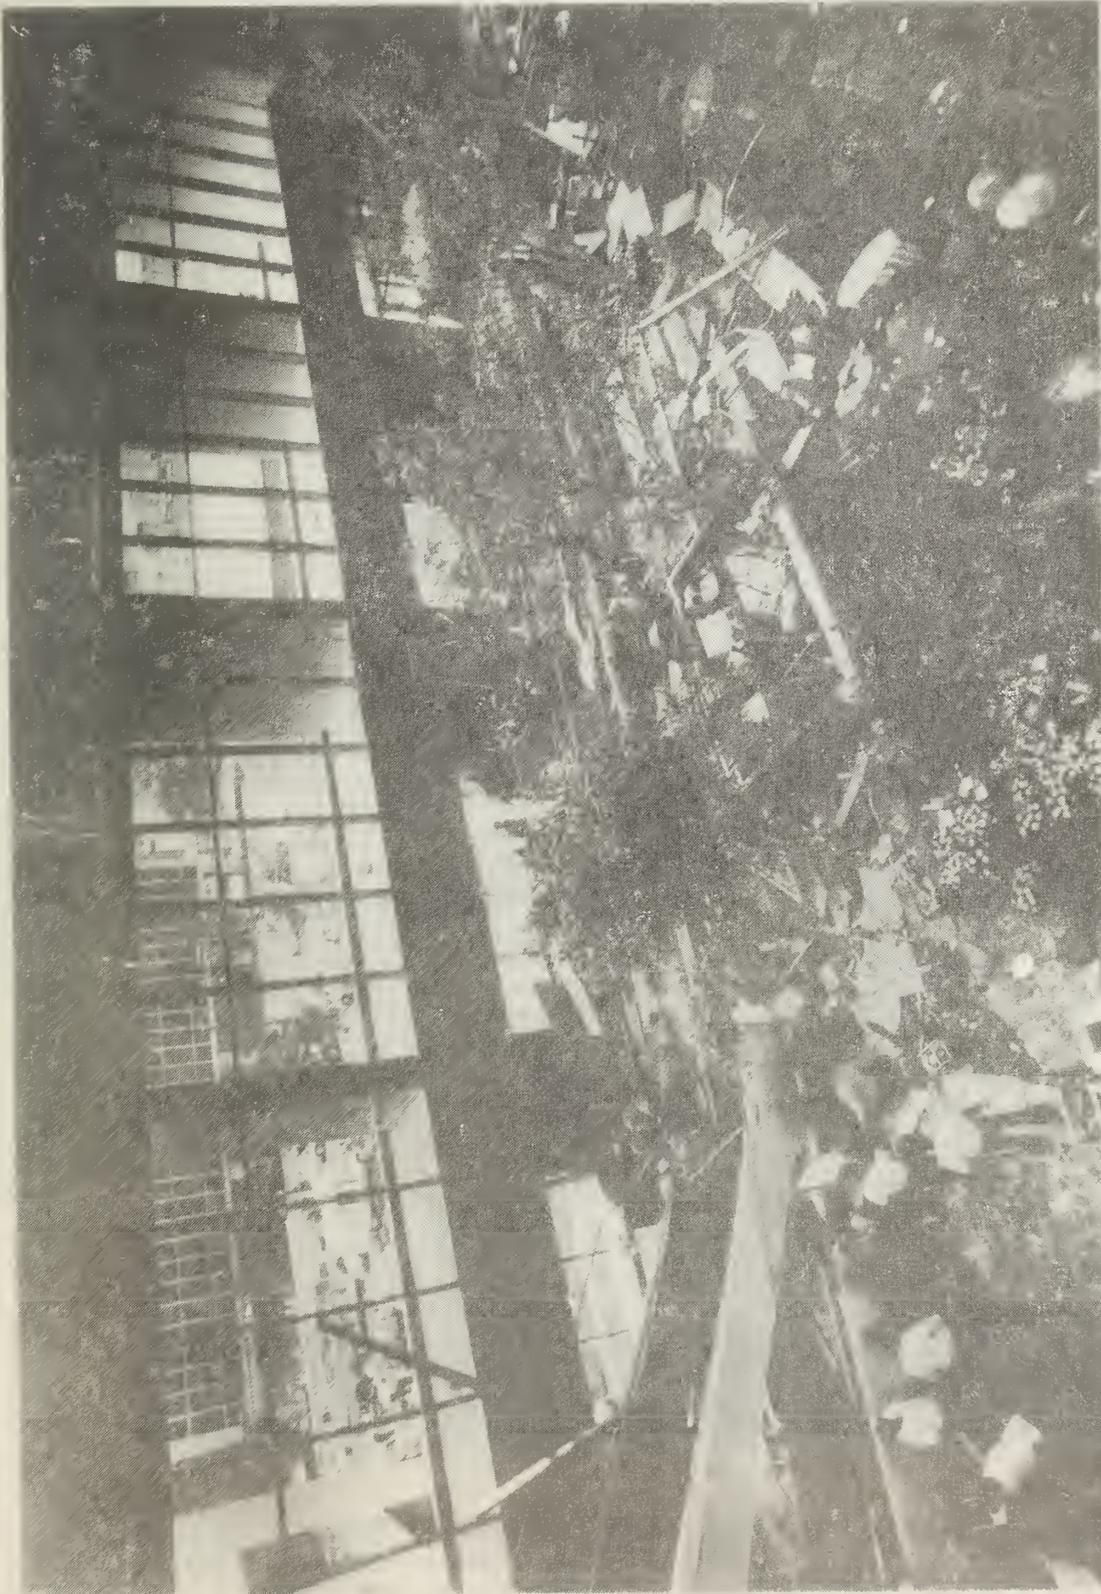
Figures 4.1 and 4.2 show the walkways shortly after the collapse, just as the rescue operation was getting under way. The photograph in figure 4.1 appears to have been taken from the stairway landing at the south side of the atrium between the second and third floors. The view is to the west-northwest and shows part of span U7-8 which lodged in the second-floor portal originally occupied by span L7-8. Spans U8-9 and U9-10 can be seen behind the trees in the middle of the picture. The photograph in figure 4.2 was taken from the third floor with the view directly to the north along the axis of the walkways. Span U7-8 is in the foreground and the third floor walkway can be seen to the upper right. Span U10-11 is visible at the far (north) side of the atrium. The north end of this span appears to have experienced an appreciable displacement to the west during the collapse. Water is coming from walkway sprinkler pipes severed when the north walkway spans were pulled off of their bearing seats.

Figure 4.1 Walkways shortly after the collapse. View is to the west-northwest with span U7-8 sloping down and to the right. Spans U8-9 and U9-10 are visible behind the trees. Photo by Greg Smith, reprinted by permission of The Kansas City Times, © 1981, The Kansas City Star Company.

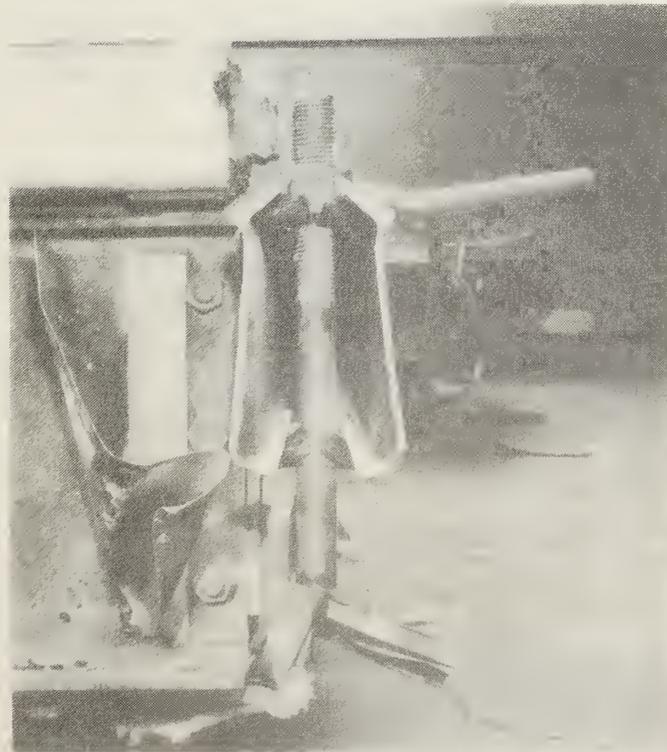
Figure 5.8 End view of box beam at location 9UE.

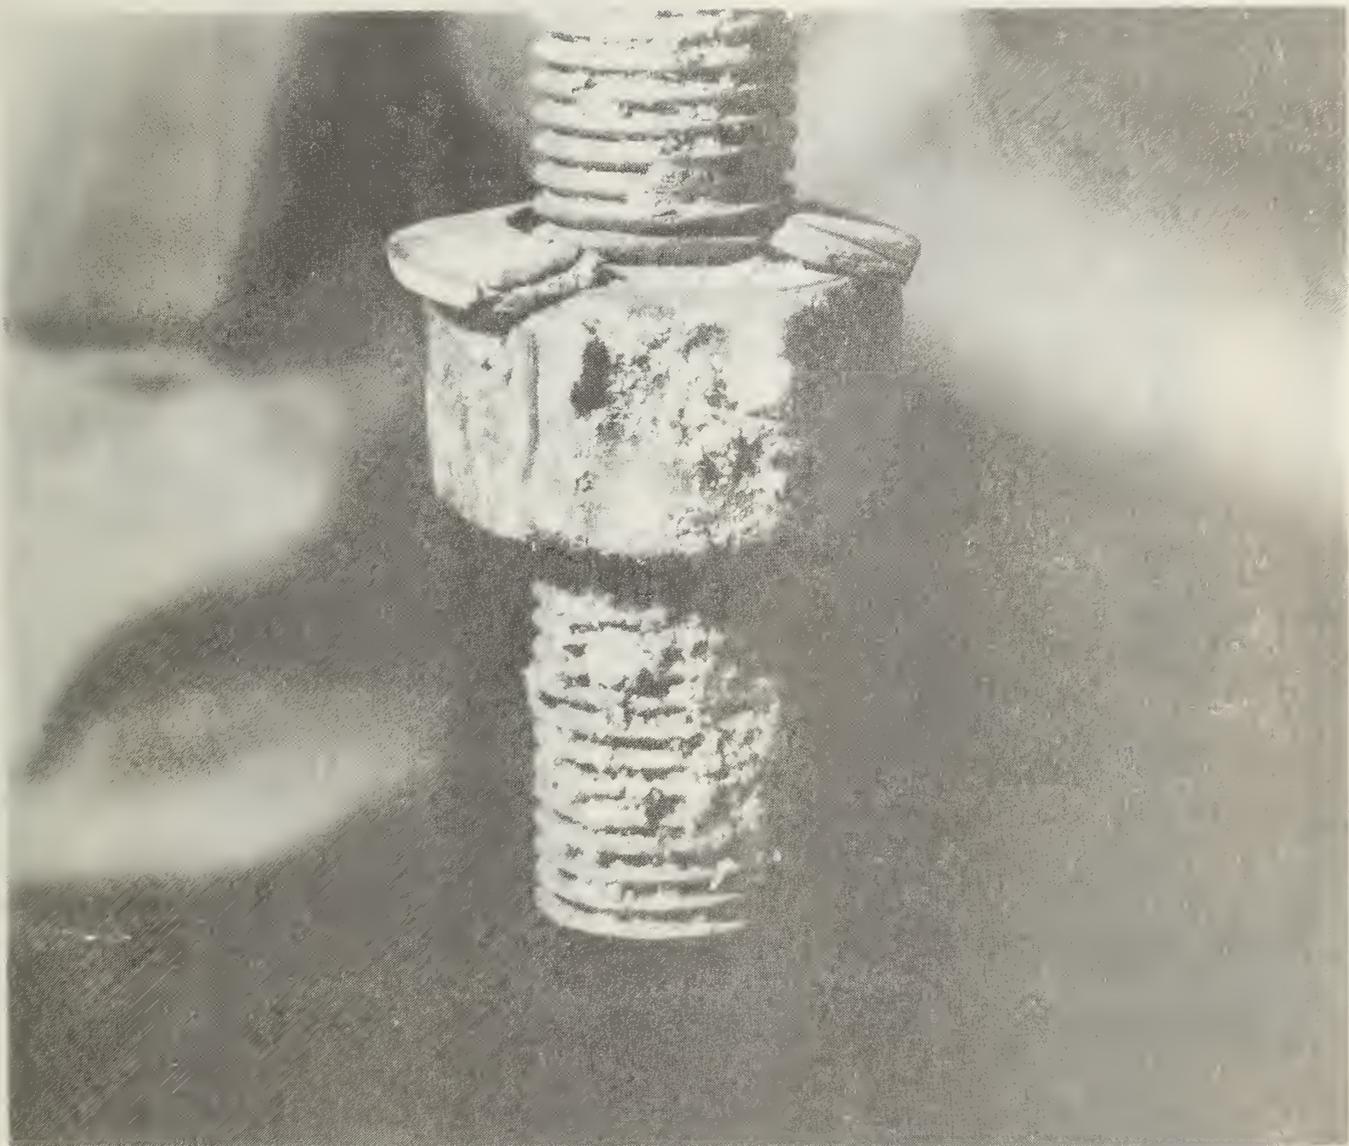
Figure 5.13 Washer at bottom end of fourth floor to ceiling hanger rod 9UW.

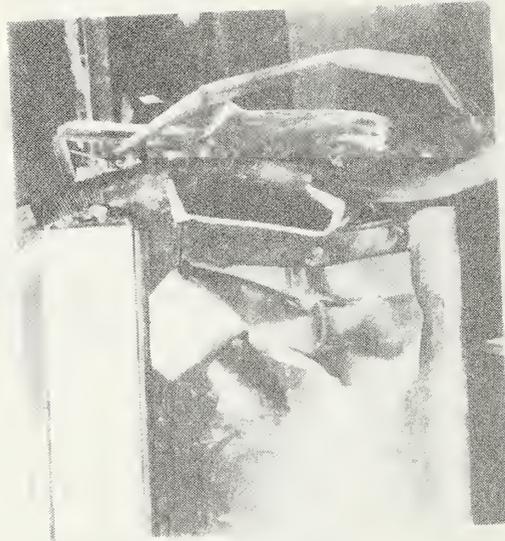
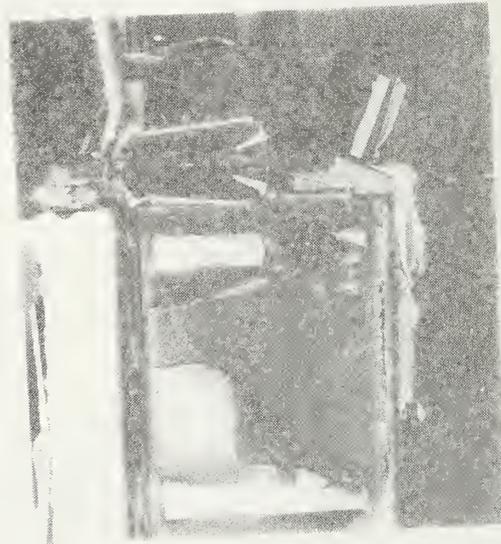
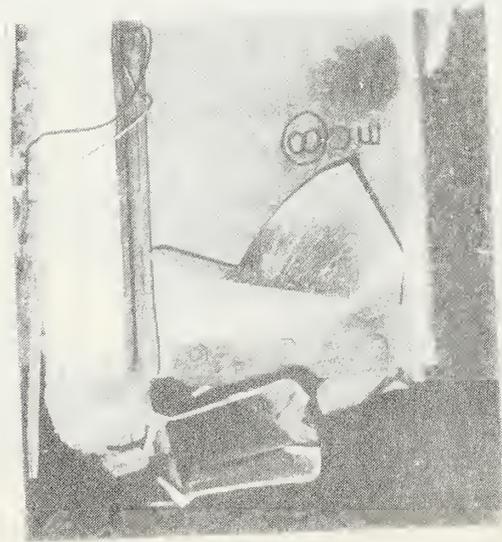
f) Location 10UE.

e) Location 9UE.

d) Location 8UE.

Figure 5.14 Observed symmetry of distortion of box beams at locations 8U and 10U relative to the box beam at location 9U.

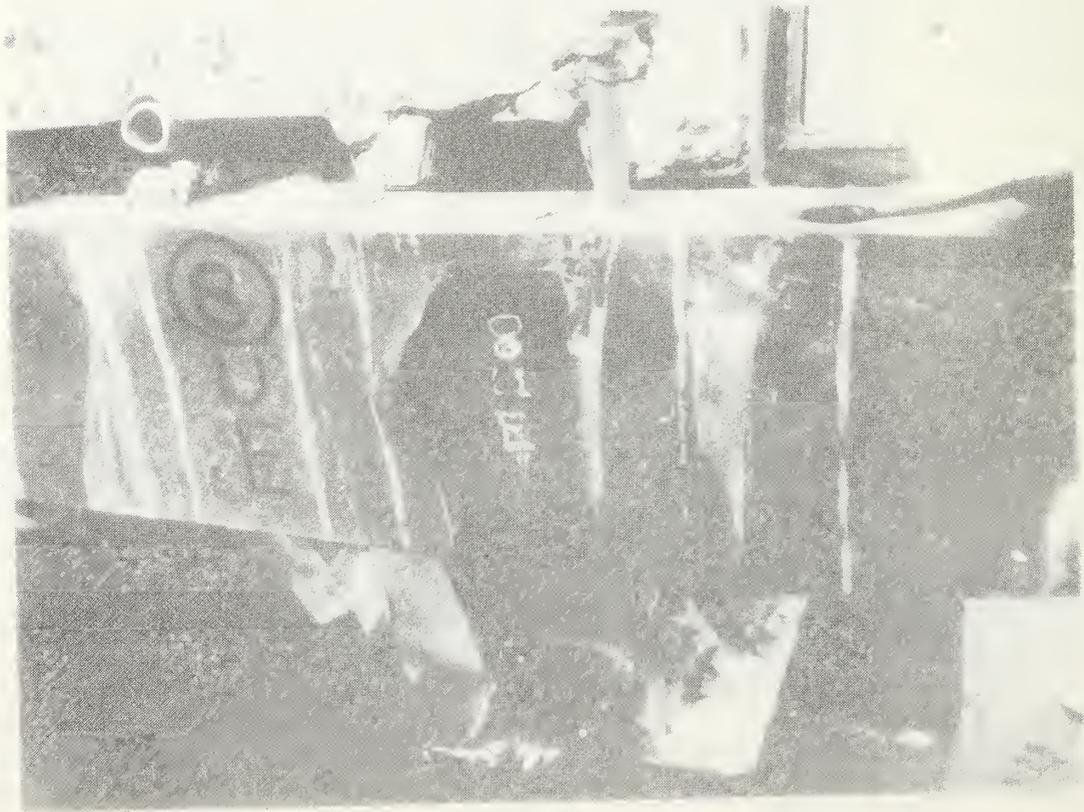
Figure 5.24 Tear in box beam web at location 8UE.

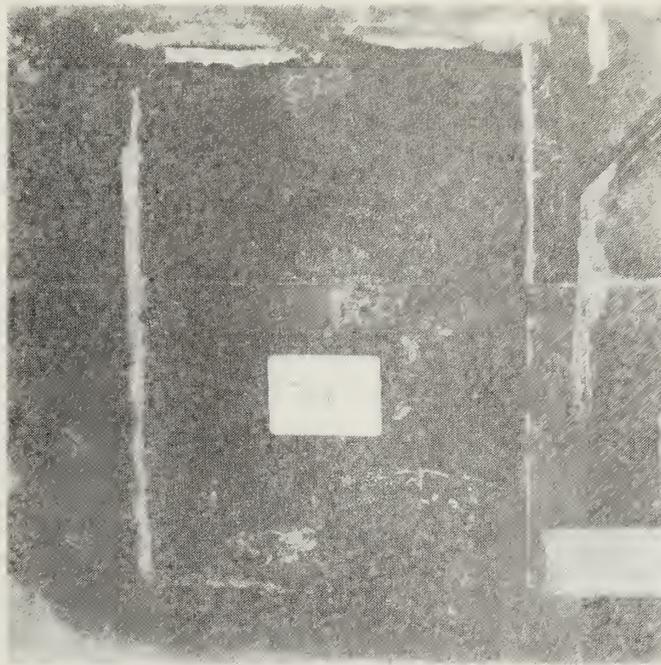
Figure 5.25 Embedded plate at connection 7UE.

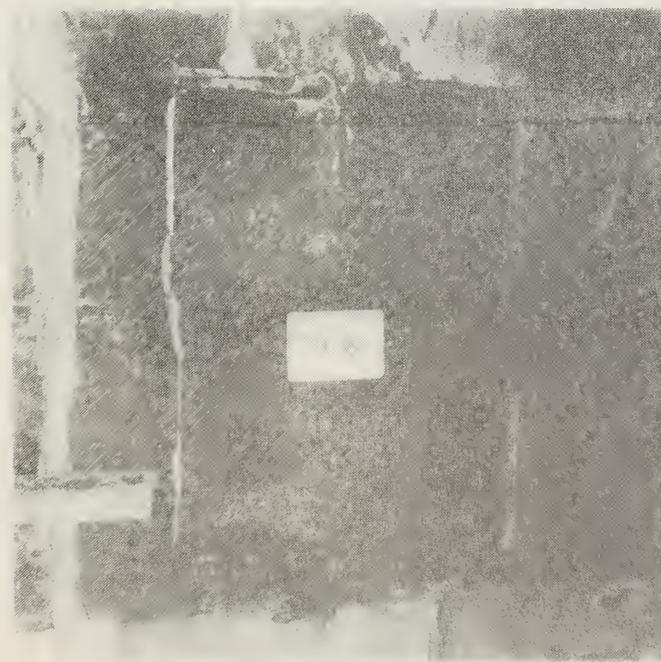
Figure 5.26 Embedded plate at connection 7UW.

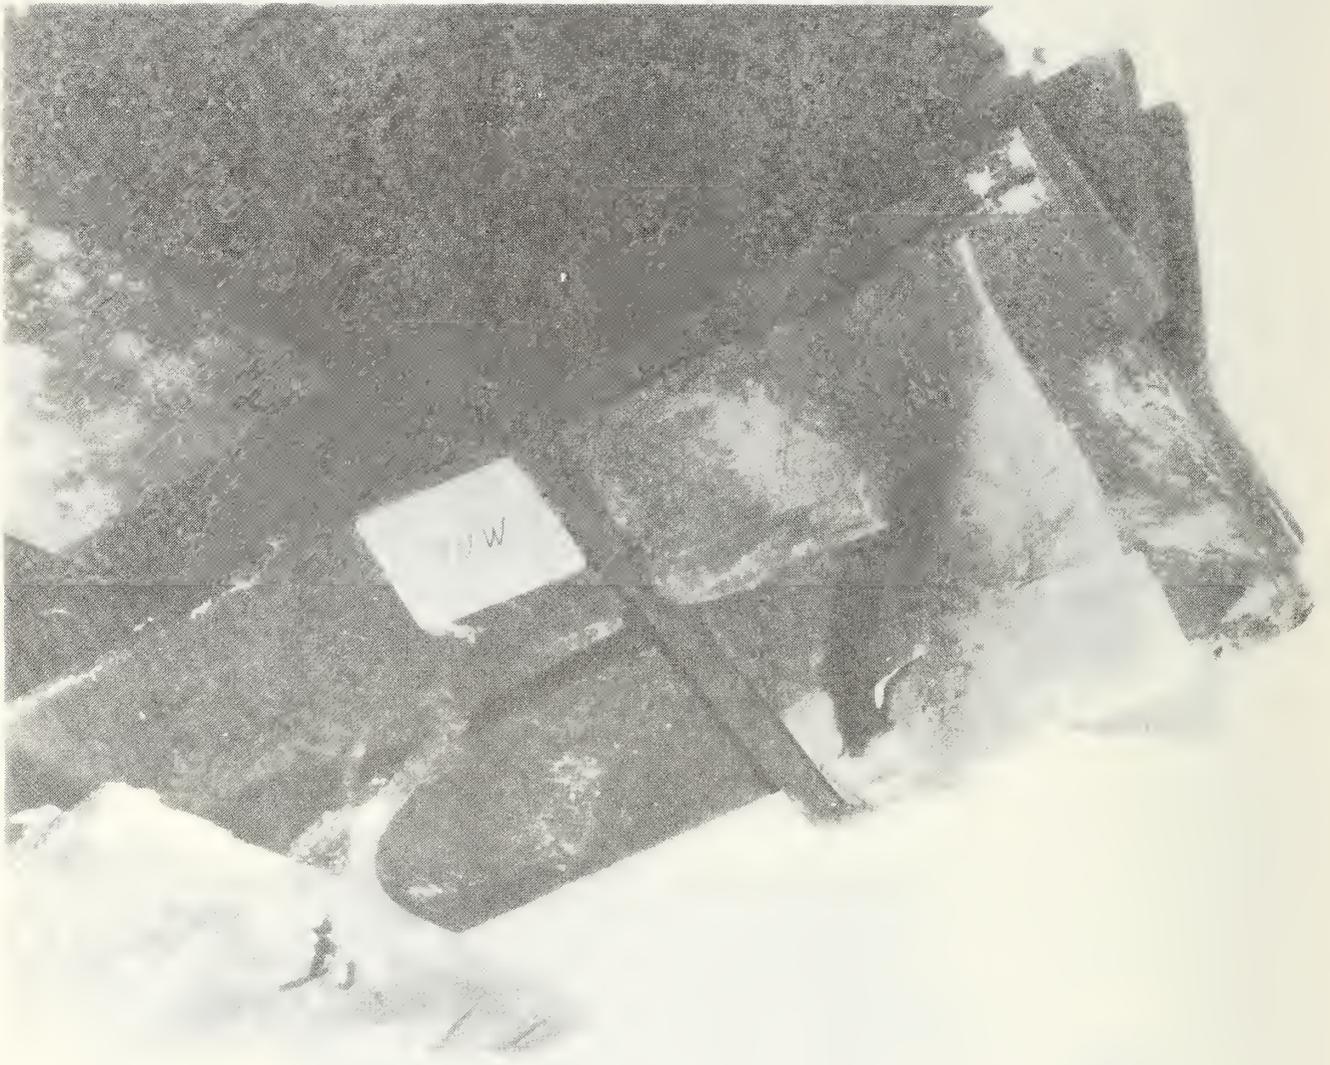
Figure 5.27 Modified bearing pad at location 11UW.

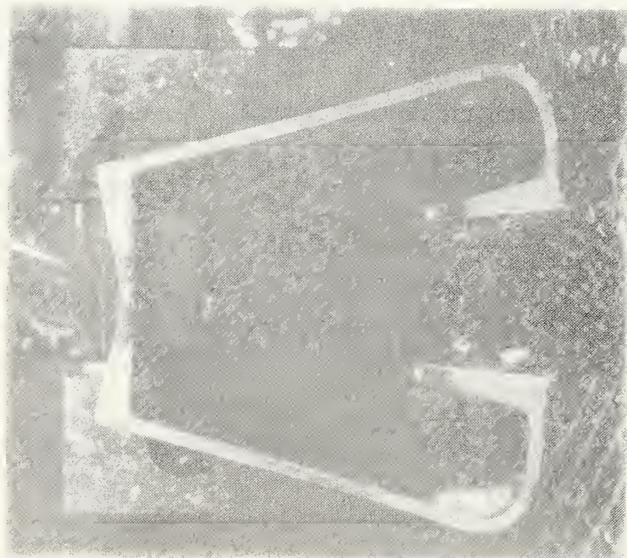
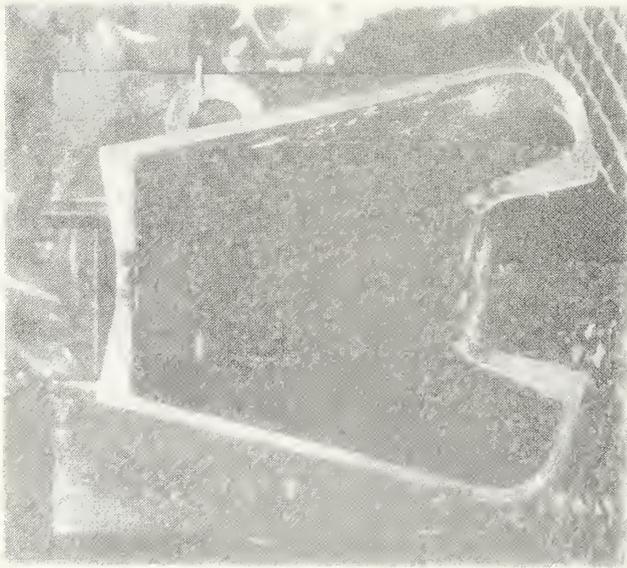
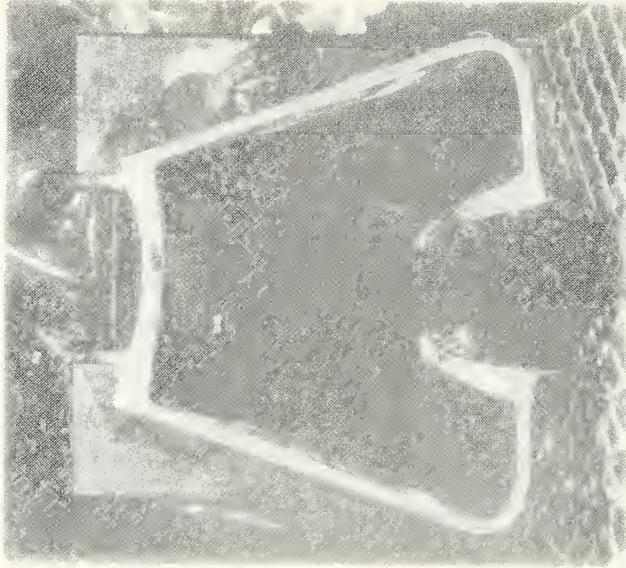
Figure 6.14 Deformed shapes.

Three different failure types, assigned the identifiers I, II, and III, were observed and are shown in figure 6.14. The bottom flanges of specimen K2, and others exhibiting type I behavior, fold back about a plastic hinge in the web and do not show any discernible bending. The flanges in type III behavior, illustrated by J1, fold back about the plastic hinge in the web but also show pronounced bending in the flange. Type II behavior exhibits slight bending in the flange tips as illustrated by specimen M1. None of the washers fractured in these tests.

not yet fractured between the exterior hole and the beam end. The resistance to load decreases with increased deflection, but at a constant rate. The rate is quite similar to the load loss rate following the peak load in the type I behavior. The gradual loss in resistance to load continues with progressive cracking until the interior weld between the outer hole and the beam end fractures, at which point there is a sharp drop in load resistance. The bottom flanges exhibit pronounced bending as illustrated by specimen J1 in figure 6.14.

Type II behavior is between the two extremes (figure 6.15). Initially it exhibits the characteristics of type III behavior. However, the interior weld between the exterior hanger rod hole and beam end fractures at or just after the peak load, unlike the type III beams. The bottom flanges appear more like type I but show a small amount of bending as for specimen T3 in figure 6.14.

Type I Specimen K2

Type II Specimen M1

Type III Specimen J1

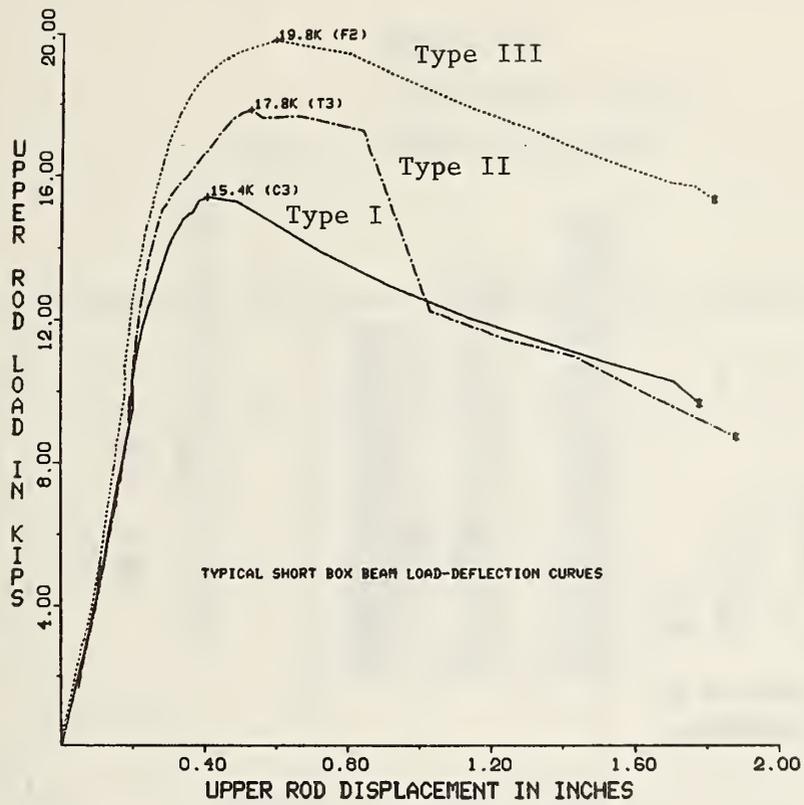
Figure 6.15 In-plane load deflection curves for specimens C-3, F-2, and T-3.

Three typical in-plane load-deflection curves for the short box beam specimens are shown in figure 6.15. (A complete set of load-deflection curves is presented in appendix A.6.10.) Each curve is a plot of the load measured by the upper rod load transducer versus the displacement of the rod measured by the LVDT at the box beam terminus of the upper loading rod (LVDT no. 2 in figure 6.13). The peak load achieved by each of the specimens is shown on their respective curves. The asterisk on each curve indicates the end of reliable measurement by the displacement device and does not necessarily denote final rod pull-through.

The in-plane load-deflection curves in figure 6.15 illustrate specimen behavior usually associated with failure types I, II, III and are again illustrated by specimen C3, specimen T3, and specimen F2, respectively.

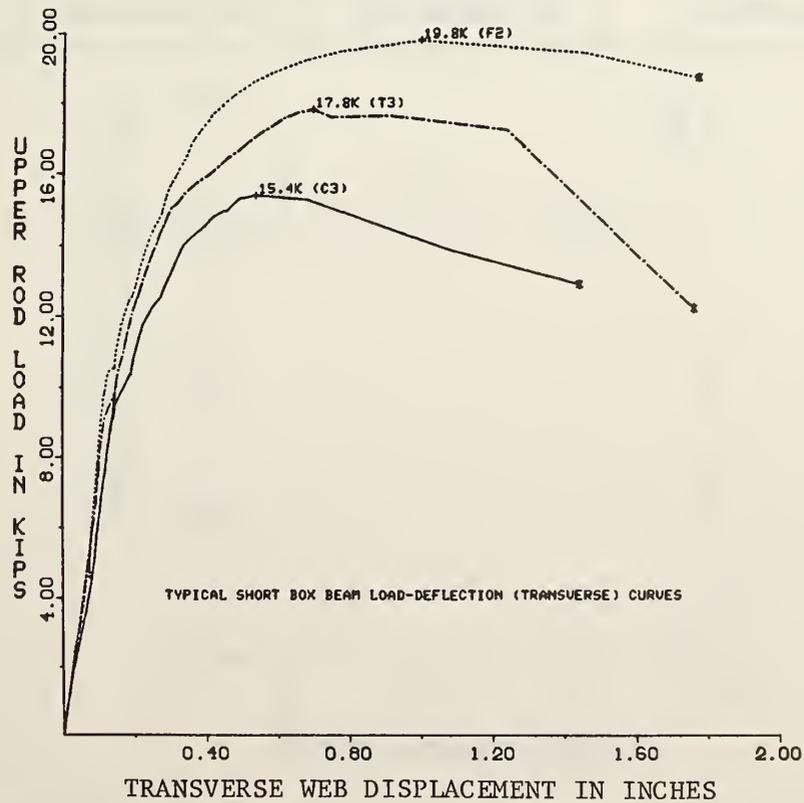
Figure 6.16 Out-of-plane web load displacement curves for specimens C-3, F-2, and T-3.

The out-of-plane load-deflection curves show the same trends as exhibited by the in-plane load-deflection curves. The out-of-plane load-deflection curves for the above described specimens are shown in figure 6.16. Each curve is a plot of the same load described for figure 6.15 versus the displacement measured by the middle transverse LVDT (figure 6.13). These data show that the web is beginning to deform outward shortly after the application of dead load from the second floor is started.

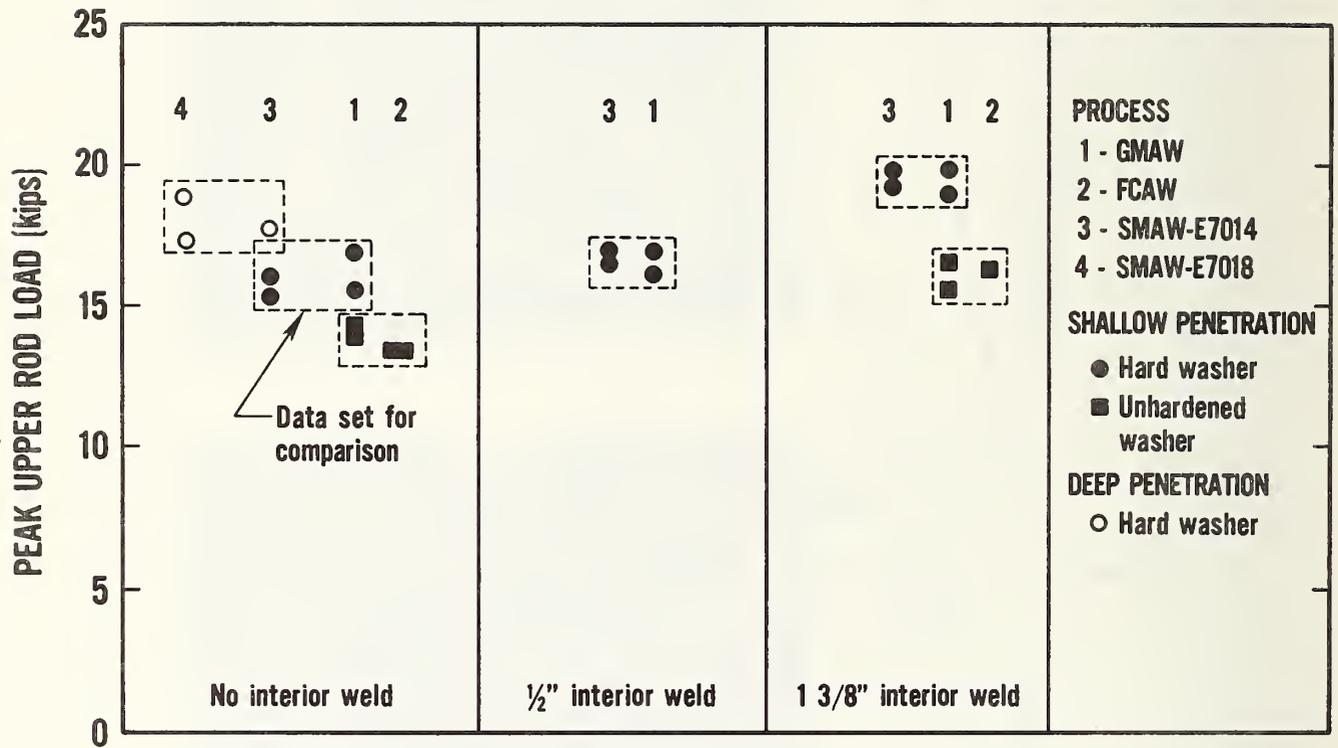
Figure 6.17 Effect of weld process.

Comparisons between specimens in which the only intentional difference is the welding process appear in figure 6.17. Six sets of data, each consisting of comparable specimens, are shown enclosed in the figure. Hardened washer data are used where possible since it was found (section 6.10.5) that hardened washers were used in the actual walkway construction. The specimens compared for a particular process were fabricated at the same time. This selection of data was done to maintain as much similarity as possible since there was variation in the amount of weld material deposited and, as discussed in section 6.10.4, the peak upper rod load was later found to vary in proportion to weld area.

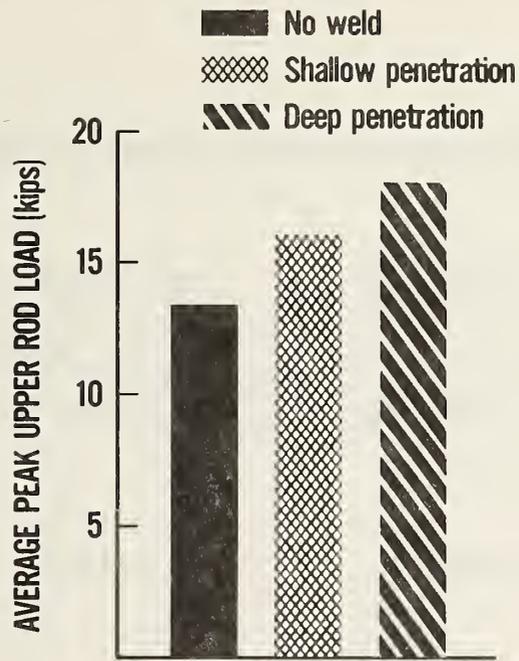
Figure 6.18 Effect of exterior weld penetration.

Exterior Weld Penetration. The exterior weld penetration depth for specimens without an interior weld has a significant effect on the peak upper rod load of the short box beams, as shown in figure 6.18. The average peak loads for specimens E1 and E2 having no weld (no penetration), C1 and C3 having a shallow penetration weld, and A1 and A2 having a deep penetration weld are shown in the figure to illustrate that there is significant difference in load resistance between the case of shallow penetration and deep penetration. The difference is about 2.5 kips (11.1 kN).

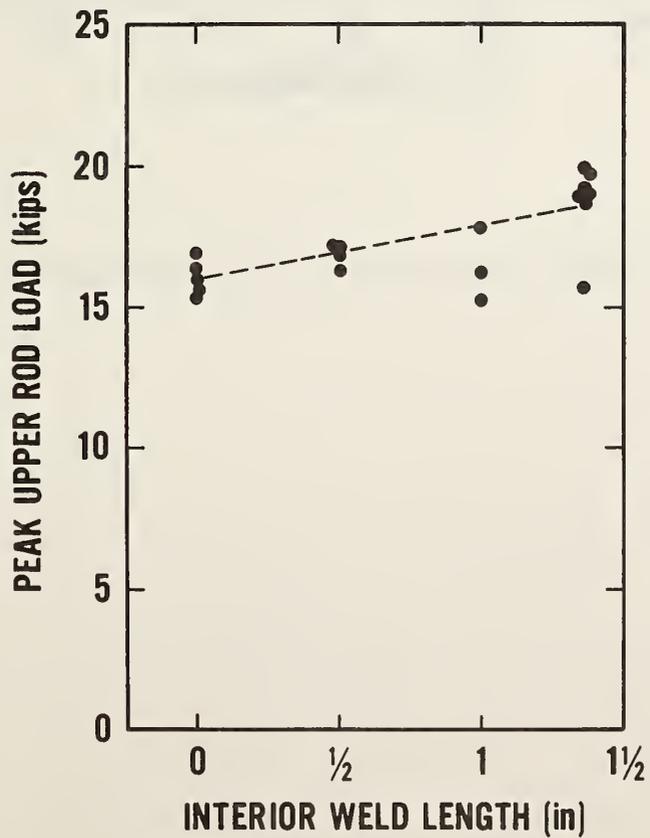
Figure 6.19 Effect of interior weld length on peak load.

Interior Weld Length. The length of interior weld has a significant effect on load resistance of the short box beams. A limited comparison of test results is shown in figure 6.19 to illustrate this point. Data shown include shallow penetration weld specimens shown in table 6.1 except for variations due to weld position, washer thickness, nut shape, nut orientation, clip angle presence, initial rod load, and number of rods. Although a regression analysis was not done it is apparent that increasing the interior weld length increases the load resistance. The increase in load resistance is roughly linearly proportional to the increase in interior weld length. However length of interior weld alone is insufficient to account for load variation since it does not consider penetration of either the interior or exterior welds.

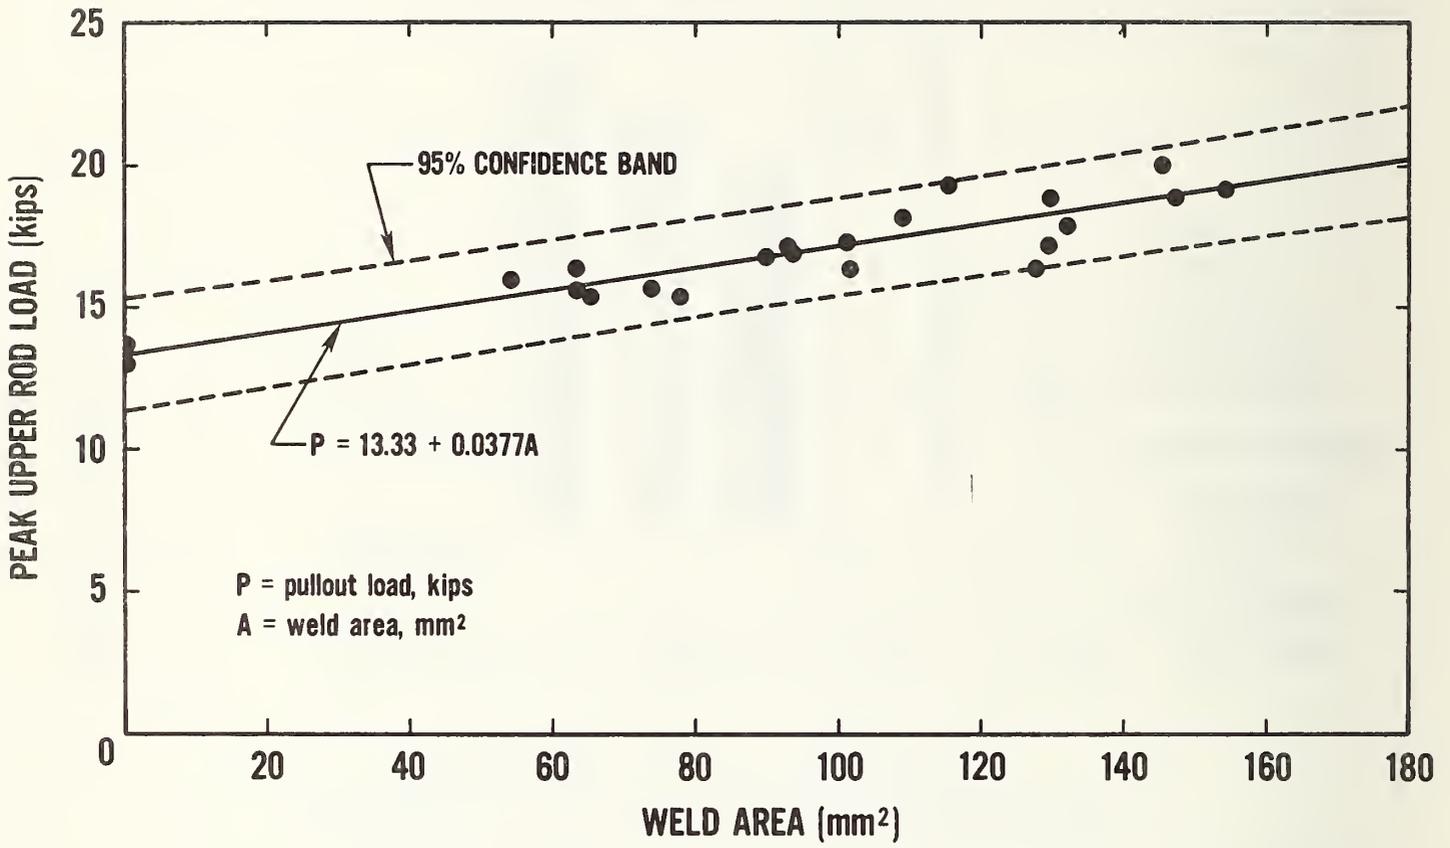
Figure 6.20 Effect of weld area on peak load, hardened washers.

Weld Area. The effect of weld length and depth of penetration of the exterior and interior weld was examined by determining the interior and exterior weld areas between the beam end and the hole for the fourth floor rod. Fracture surfaces between the exterior hole and beam end were examined under magnification for all short box beam specimens. Lengths and depths were measured. Depths were measured at five locations and averaged. These average measurements are summarized in tables 6.1, 6.2, and 6.3, and 6.4 for the NBS tests. Weld area was determined as the sum of the products of the average depth and length for the exterior and interior welds. The peak upper rod load is plotted in figure 6.20 against the weld area. Weld area is used as a measure or index

The data shown in figure 6.20 include all tests on short box beams with hardened washers as listed in table 6.1 except for round nut bevel, initial rod load, single rod and clip angle presence. These latter parameters are discussed in section 6.10.5.

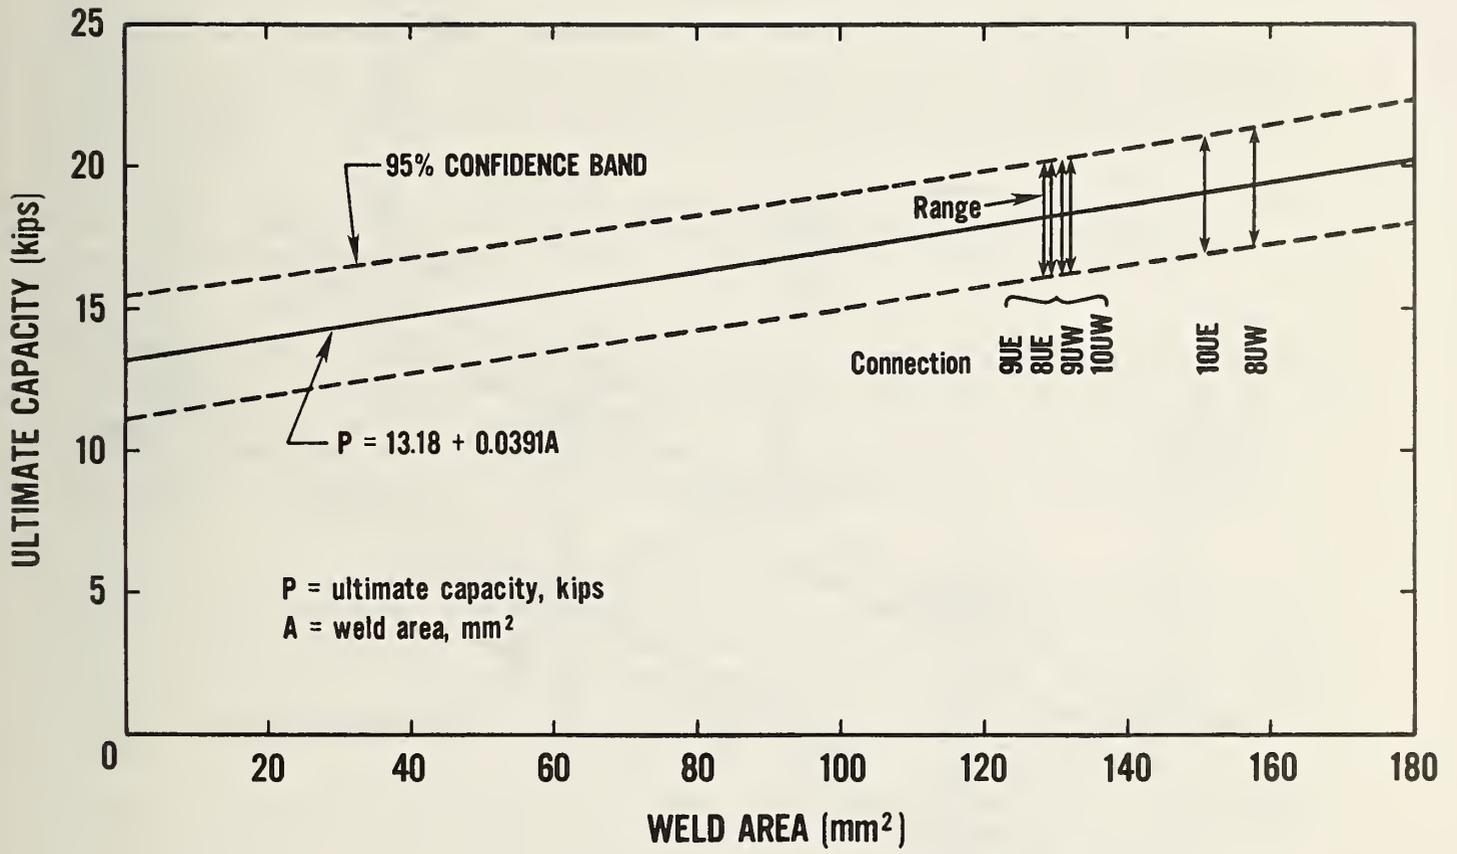
Figure 6.38 Estimated ultimate capacity for walkway box beam-hanger rod connections.

The regression equation shown in figure 6.38, along with the 95 percent confidence band for single values of pullout load, is used to estimate ultimate strengths for the fourth floor box beam-hanger rod connections. The figure is the same as the one shown in figure 6.31, but with the data points omitted. It was developed based on the short box beam data described in section 6.10.6 and the full-length box beam data described in section 6.11. Furthermore, the regression analysis was validated by the use of actual walkway test specimens.

The meaning of figure 6.38 is amplified by discussing box beam-hanger rod connection 9UE as an example. Simply described, if many specimens like 9UE were tested, their average should fall close to the regression line. However, for a single test one can be 95 percent confident that the test result would fall within the 95 percent confidence band. Thus each connection should be thought of in terms of the range of ultimate strength as well as the average.

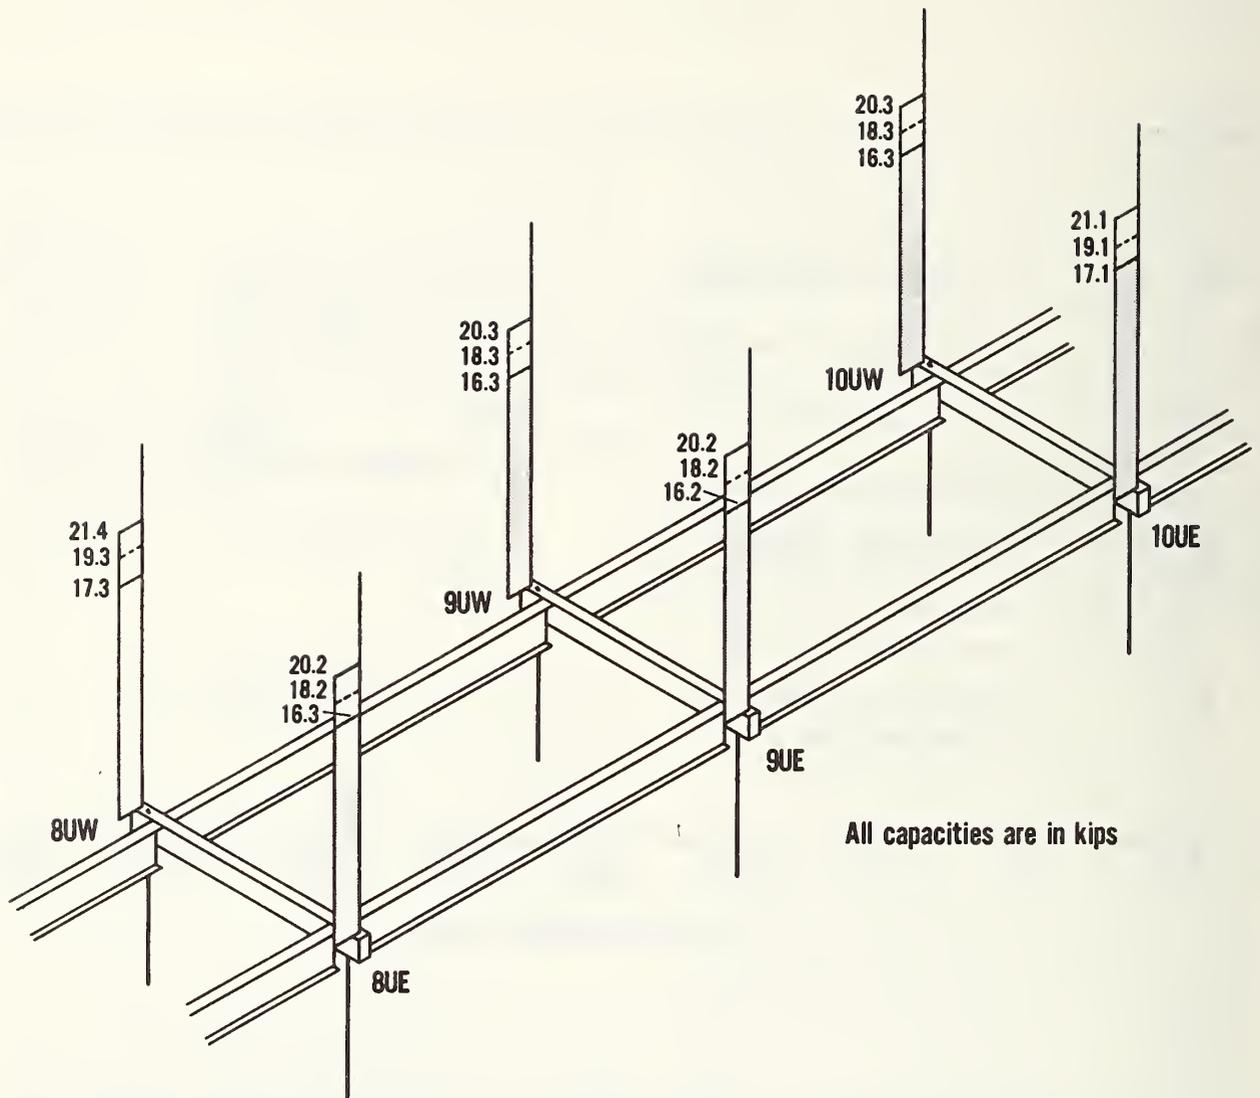
Figure 6.39 Summary of ultimate capacities.

These ultimate capacities are summarized in figure 6.39 on a layout of the six box beam-hanger rod connections. A bar diagram is shown adjacent to each hanger rod. Location 8UE is described to denote the meaning. The range from 16.3 to 20.2 kips (73 to 90 kN) is the 95 percent confidence interval estimate

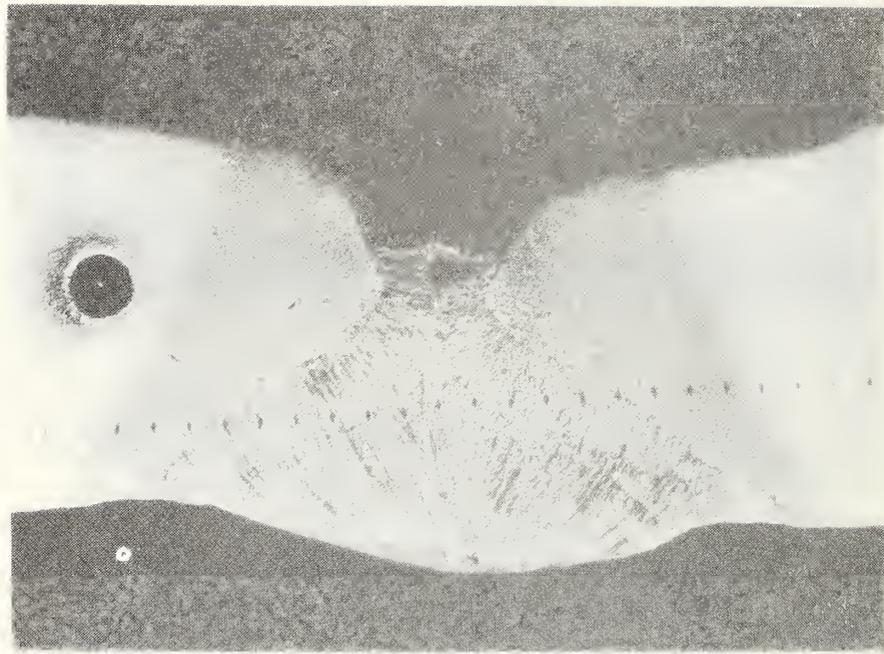
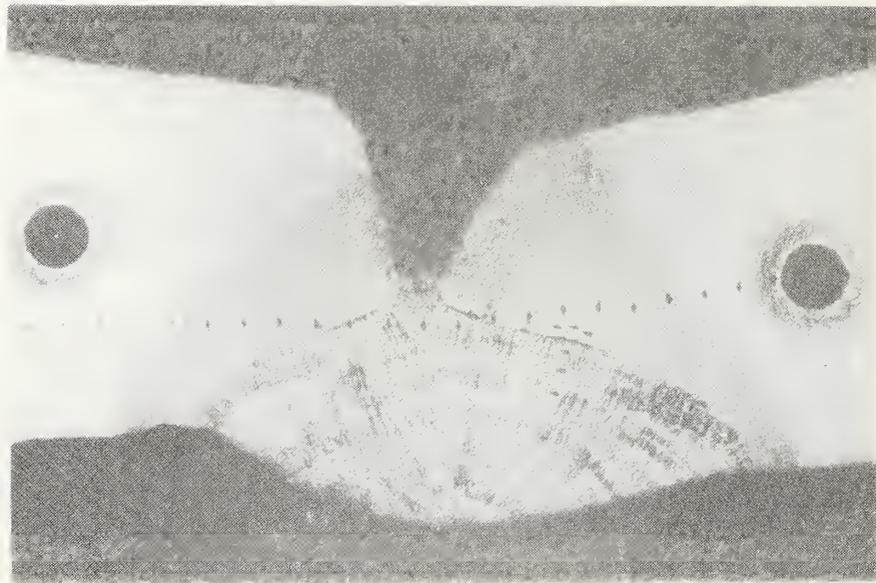
Figure 7.10 illustrates the appearance of an NBS weldment made by the GMAW process, while figures 7.11-7.13 illustrate the appearance of weld regions in box beams 9U, 8L and 9M, respectively. Basic walkway weldment hardnesses were normal. Maximum hardnesses were 92-95 Rockwell B (HRB) for the weld regions, 85-93 HRB for the heat-affected zones and 70-79 HRB for the unaffected parent metal. Small zones of increased hardness (28-33 HRC) were noted in the heat-affected zones of one section taken from location 9U and one section taken from location 8L. The structure of the hard zones appeared to be tempered martensite.

Figures 7.10 to 7.13 illustrate a substantial variability in the contour of the mating flange ends forming the faying surfaces for welding. The effect, coupled with differences in weld penetration, creates regions of varying notch acuity in the weld region. However, no cracks were observed to have initiated from such notches in any of the sections studied.

Figure 7.11 Cross sections through weld regions of box beam 9U (NBS 1). Sections were separated about 7 in (180 mm) along the beam length. Microhardness indentations traverse the surfaces. X 8 1/2
